Manhole Inspection Summary

Manhole # S13YY_024MH

Insp Date: **8/3/07 11:14 AM**

Location Address: **3121 SEQUOIA AVE**

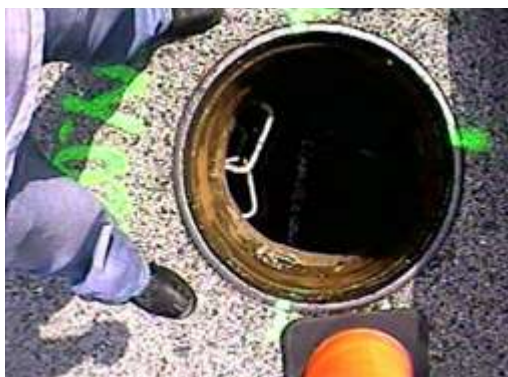
Defect 1

Offset: **2** (in.)

FRAME OFFSET

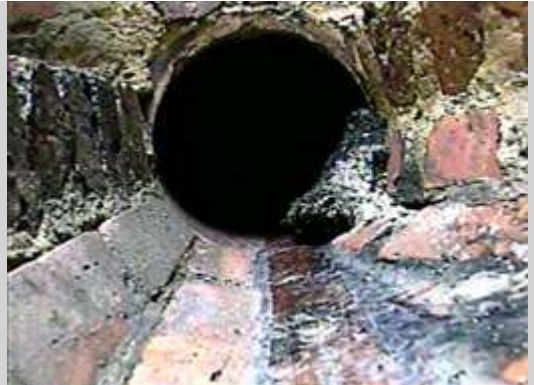
12 O'Clock Outflow

8 in. Circular Gravity Sewer
Pipe Out @ 12 O'Clock

Infiltration: **None** Pipe Seal Cond: **Broken**

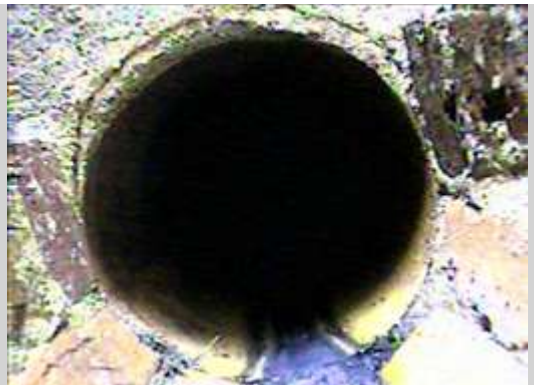
3 O'Clock Inflow

8 in. Circular Gravity Sewer
Pipe In @ 3 O'Clock

Infiltration: **None** Pipe Seal Cond: **Sound**

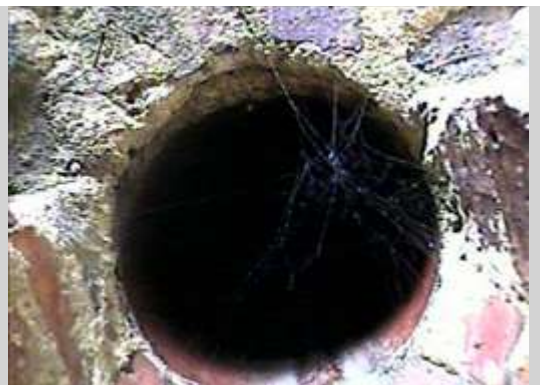
6 O'Clock Inflow

8 in. Circular Gravity Sewer
Pipe In @ 6 O'Clock

Infiltration: **None** Pipe Seal Cond: **Sound**
